## Cold Weather Rooftop Case Study – January 2009

# Vacant Building and Cold Weather Rooftop System Conducted at Vacant Facility of a Major National Retailer Location: Elk River, MN

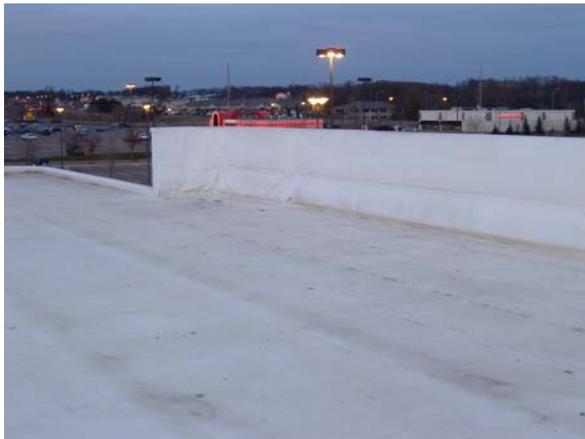
Figure 2: Rooftop with front wall and side wall

The construction of this particular building was such that there were no walls at the edge of the rooftop except for the front facade of the store. The roof met the exterior wall at a small curb.

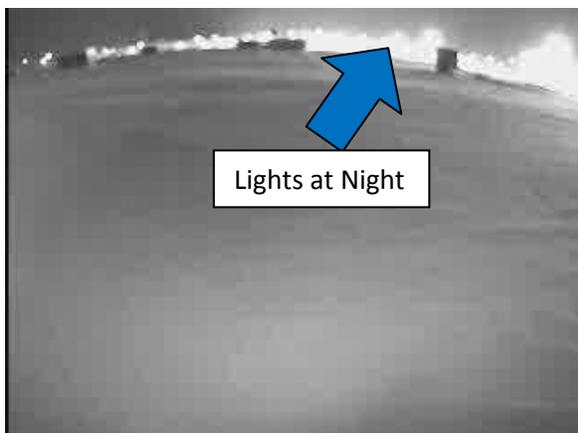
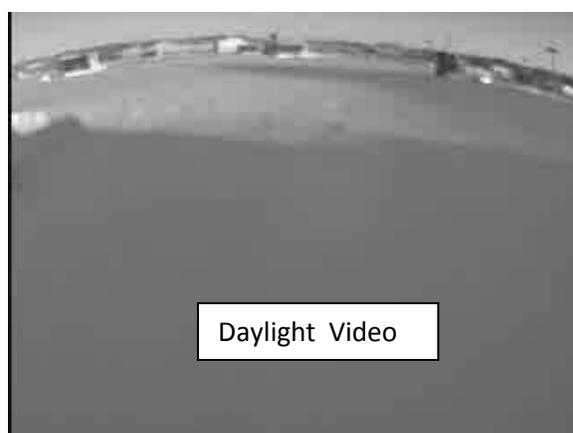
January 1, 2009 was extremely cold (-20F) with high winds, snow and blizzard conditions. On that night one of the rooftop cameras sent multiple videos of the empty rooftop and blowing snow. This was both puzzling and concerning. The outdoor camera/detectors have been proven to be stable in both thunderstorms and blizzards, even going through Hurricane Ike on the Gulf Coast. This was abnormal and was initially attributed to a defective camera/sensor.

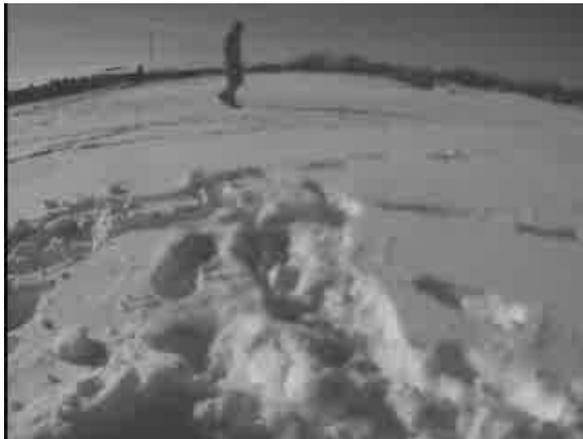
**Figures 3: Video of Security Personnel on rooftop at -22F**

The integrator went to the sight January 15 to investigate the cause of the detections. What was encouraging was that as soon as security personnel reached the rooftop, the camera/sensors detected them and sent videos as expected. Before approaching system, security personnel tested both cameras and they functioned as expected. These two videos show the security personnel as they come across the roof at -22F. This is exceeded the specified operational range of the system.

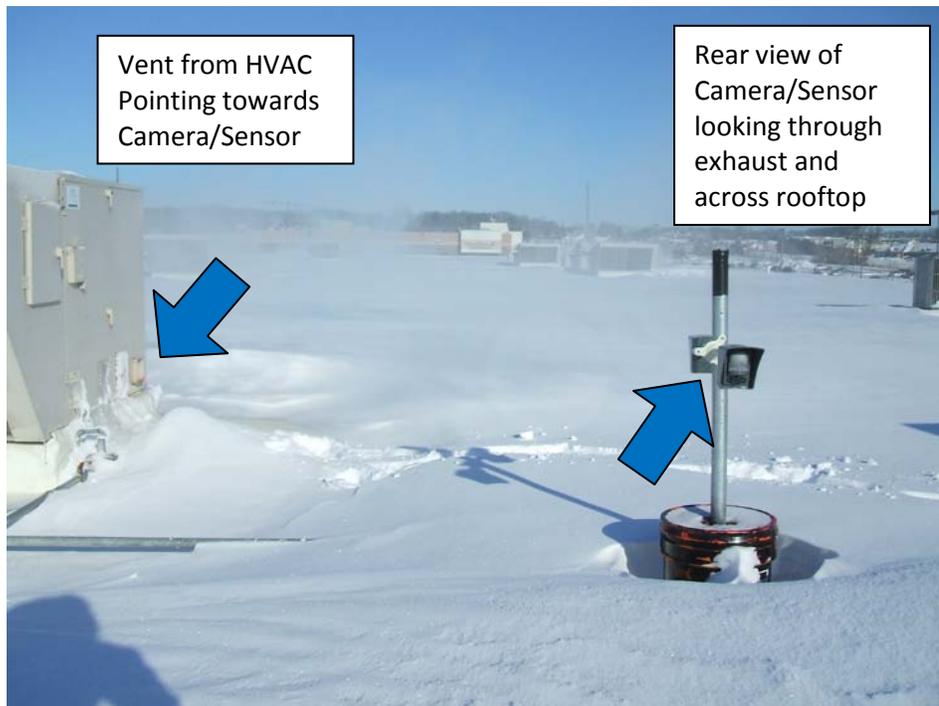
Once on site, the integrator found the cause of the PIR activations. The camera/sensors were installed 8-10 feet from a small exhaust vent on one of the HVAC units. This vent pumped out warm moist air in the direction of one of the camera/sensors, the one that was sending the videos.

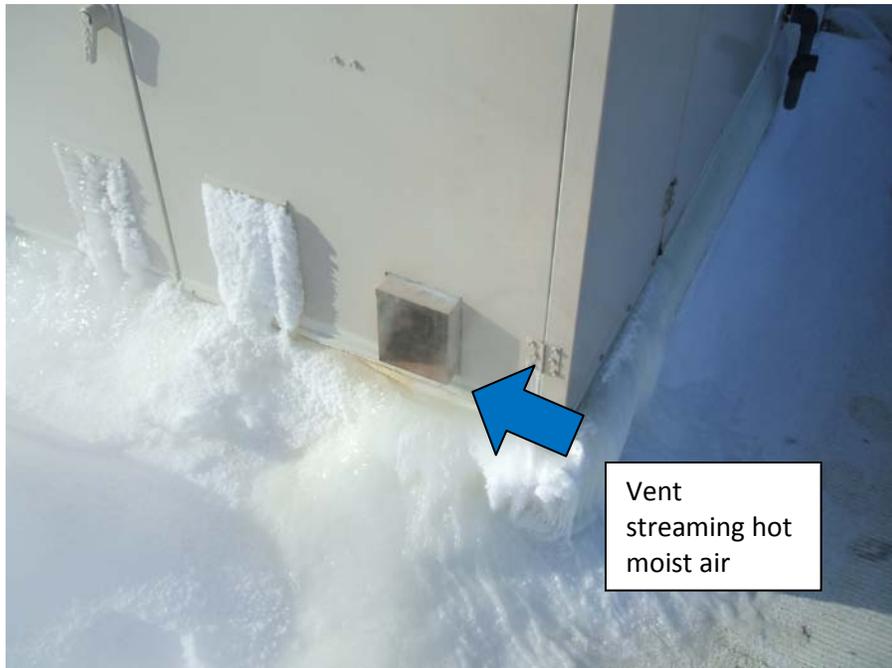
It was this unexpected venting of hot moist air that was causing the Passive Infrared Motion detectors to trip and activate the camera.

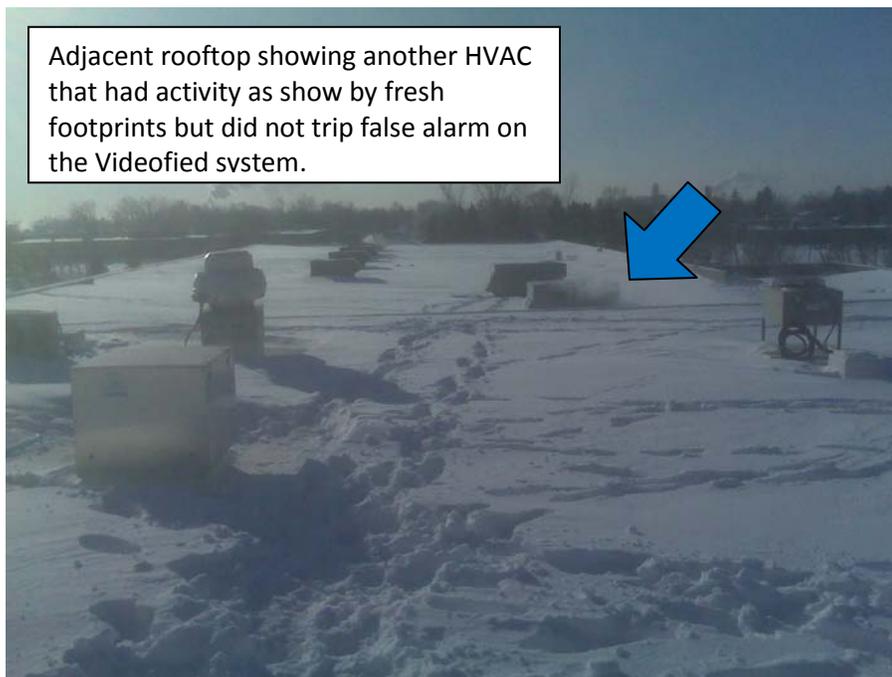
While inspecting the site the integrator noticed that there had been activity on the adjacent rooftop by repairmen as evidenced by fresh footprints all around their HVAC unit – Videofied detected the security personnel intrusion and ignored the activity on the adjacent rooftop as expected.
