## Cold Weather Rooftop Case Study – January 2009

# Vacant Building and Cold Weather Rooftop System Conducted at Vacant Facility of a Major National Retailer Location: Elk River, MN

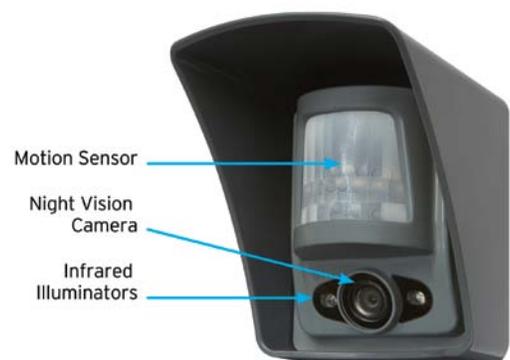
Figure 1: Outdoor Camera Mount

The Panel was mounted inside the building. Two indoor cameras were placed inside the vacant building to secure the interior. The building was heated. Two additional cameras were placed on the rooftop. These were both mounted to a short pole secured in a 5 gallon concrete filled bucket.

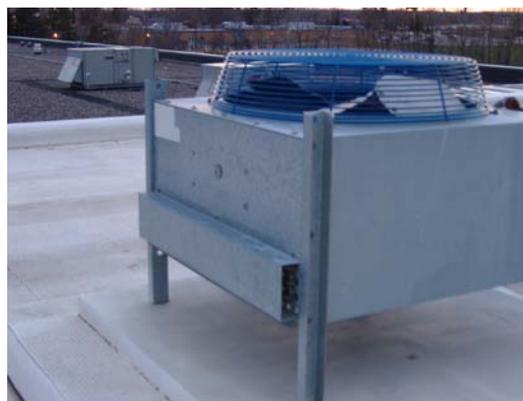
This photo shows the rooftop of the adjacent strip mall in the background.

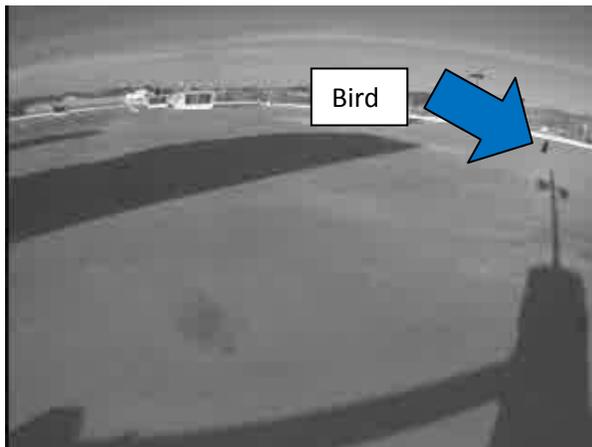
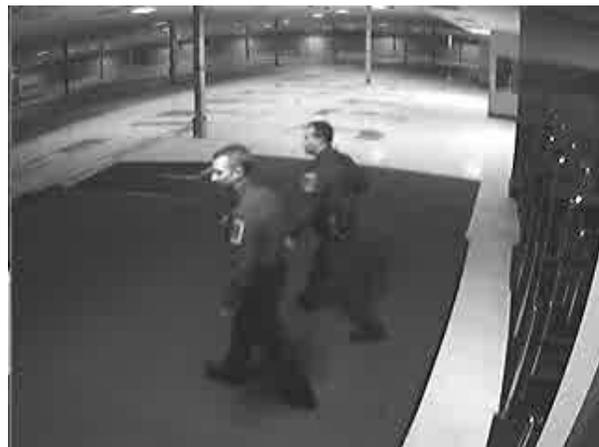
On November 26, there was a “detection” from a rooftop and the monitoring station followed procedures and dispatched police. The video showed a large bird walking around the roof. The police response to this incident was detected by the interior cameras and the video sent to the notification group.
